Service Bulletin SB STC 10070970-1

<small>LBA-CAO-0035 DE-CAO-0035</small> Ingenieurbüro Calsbach UG	<h1>Service Bulletin</h1>	Doc.-No. 10070970-1
		Revision 0
		Date 09.08.2022
	SB STC 10070970-1	Page 2 of 5

On one of the affected series (LS4), the connecting device of the airbrake control rod broke in the area of the root rib due to incorrect assembly (a thread was drilled off-center). Since it cannot be ruled out that the threads for the ball heads on other aircraft were also drilled off-center and thus incorrectly, this Service Bulletin is published.

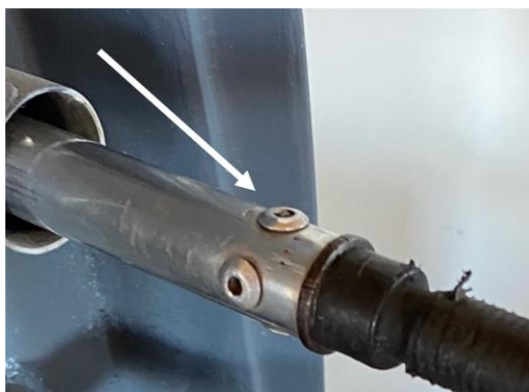
Picture 1: Installation situation old fittings

- 3.2 Drill out the found, riveted-in connection devices (the existing ones with the external thread) with the drill and the steel drill, diameter 4 mm. Be very careful when doing this, because later the newly supplied and modified connection piece will be inserted and riveted in the same position.

- 3.3 Now pull the respective connection device out of the control rod. The old connection heads are glued in the push rods by epoxy resin. To loosen this bond, it may be needed to use a heat gun to heat the connection head to max 100° C., before pulling out the head from the push rod. When doing so, make sure that the ball head is not damaged, as this will be used again later.
