# Safety Information Bulletin

**SIB No.: 2019-07**

**Issued: 30 April 2019**

**Subject:** **Sailplane Rigging – Procedures, Inspections and Training**

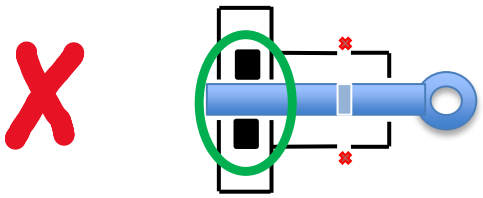
| Engaged but not secured. | The bolt moved away from its engaged position, and the control is unconnected. |

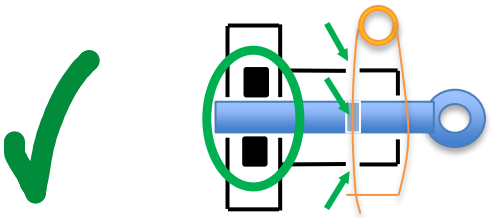
| | The Fokker-needle needs to be pushed through both holes of the cage and the hole of the bolt. |
| Engaged and secured. | |

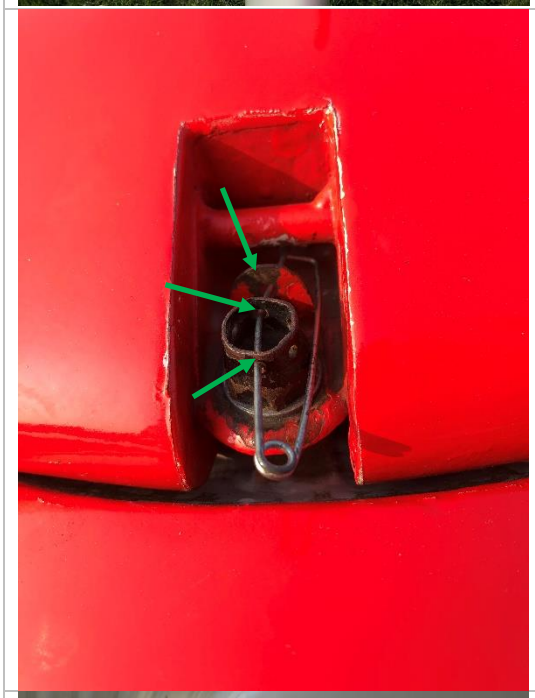
| | The bolt needs to be engaged and secured against rotation. |
| | Horizontal stabilizer enganged in its aft fitting but forward fitting not engaged. |

*Note: All cases of unconnected controls and unconnected horizontal stabilizers can be detected by performing a positive control check. Non-interruption during the rigging helps to prevent forgetting the connections in the first place. The checking of proper securing can be done by a visual inspection only.*

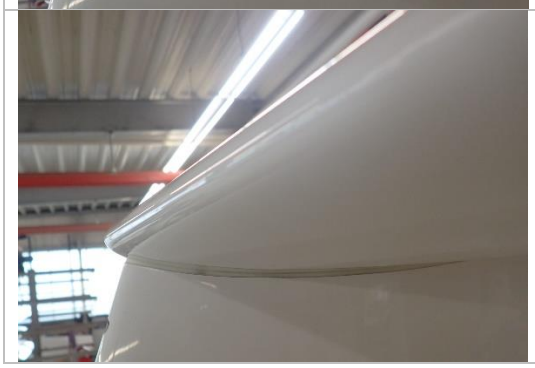
| | Horizontal stablizer properly engaged. |

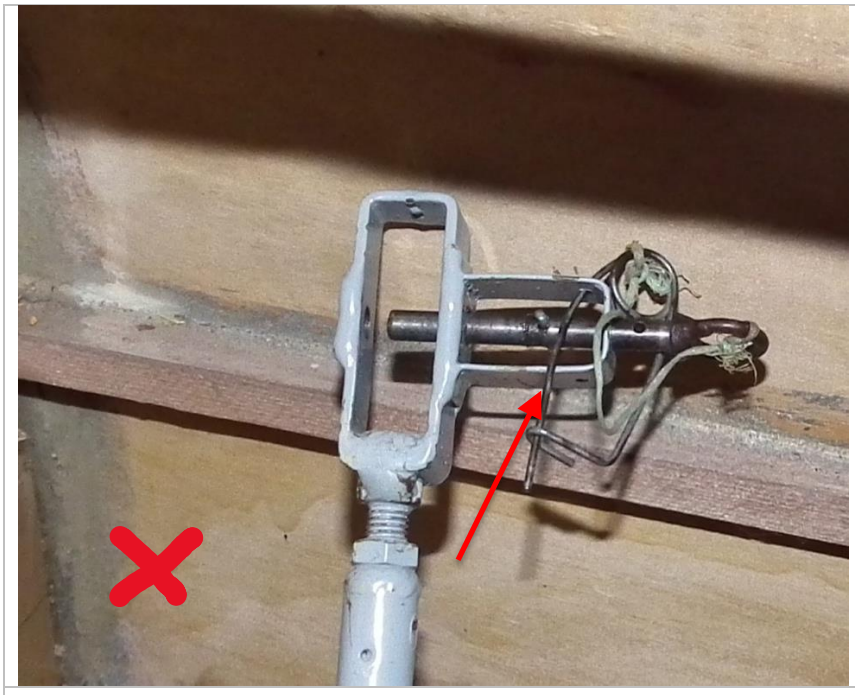
The example below shows an aileron connection, which is typical for old sailplanes with manual control connections. In this case, the connection was engaged during rigging, but not correctly secured. After three flights of short duration, the bolt moved away from its engaged position. The pilot lost control and crashed fatally.

| | The connection was not secured. The Fokker-needle was put through one hole of the cage only, but not through the bolt and the lower hole of the cage, as well. By this, the bolt could move freely and the control connection could become unconnected. |

*Note: Connections, which are not properly secured, <u>cannot</u> be detected by positive control checks. The proper securing can be verified only by a manual inspection through turning, pulling, or shaking of the bolt and further visual inspection.*

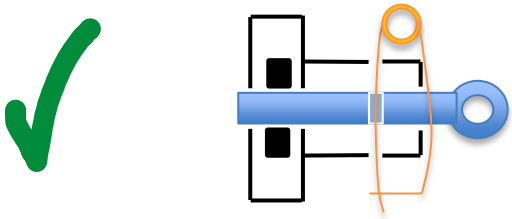
| | The bolt is secured by pushing the Fokker-needle through <u>all three</u> holes. |

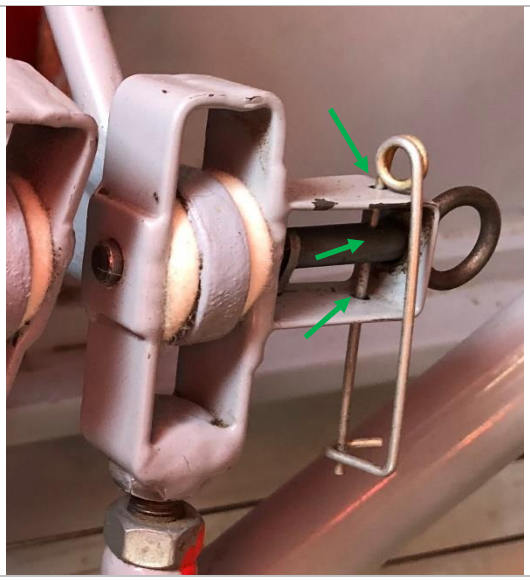
| ✓ | | A straight and not bended needle supports its proper application. |

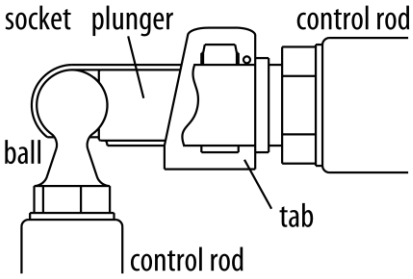
(a) Correct: cut-away shows how tab holds plunger in place

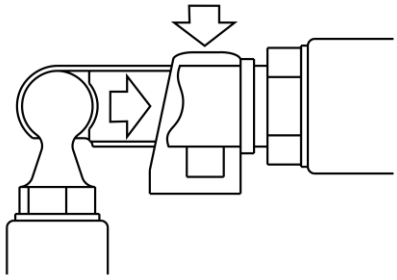
(b) Open: with tab depressed, plunger allows ball to be inserted or removed

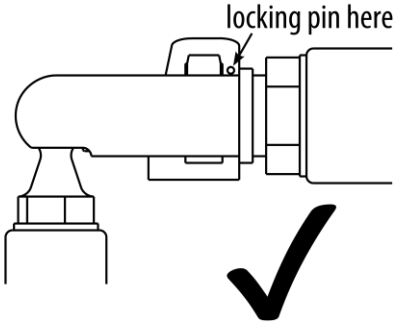
(c) Correct: ball engaged, locking pin may be inserted

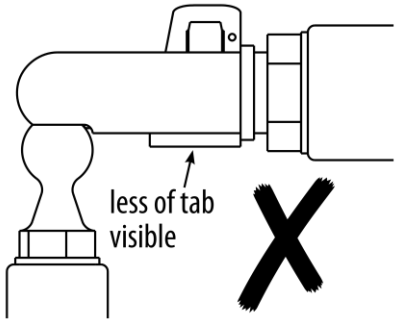
Unfortunately, the tab adopts a similar position when the ball and socket are completely disconnected and, although the ball is then locked out of the socket, it may in some cases engage sufficiently for the controls to seem connected. Being able to insert the locking pin does not guarantee that the connection has been properly made.

(d) Incorrect: ball not engaged, but locking pin may still be inserted

It is crucial to check that the ball and socket are correctly engaged. This can be difficult, if access is tight or illumination poor; a torch and mirror, or telephone camera, can help.

*Note: To check the proper engagement of l'Hotellier connectors, a positive control check is strongly recommended.*

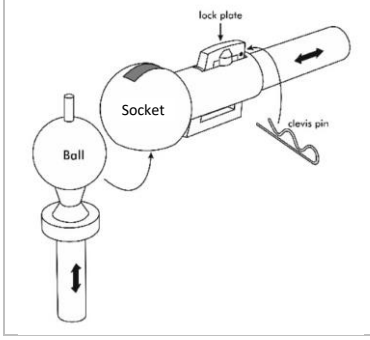
| | Newer l'Hotellier connectors come with a pin on the top of the ball that becomes visible outside the socket, once the ball and socket are properly engaged. The pin allows also for a tactile inspection. The connection still needs to be secured. |

Remark: The maintenance instructions of l'Hotellier, in particular about ball wear need to be respected.

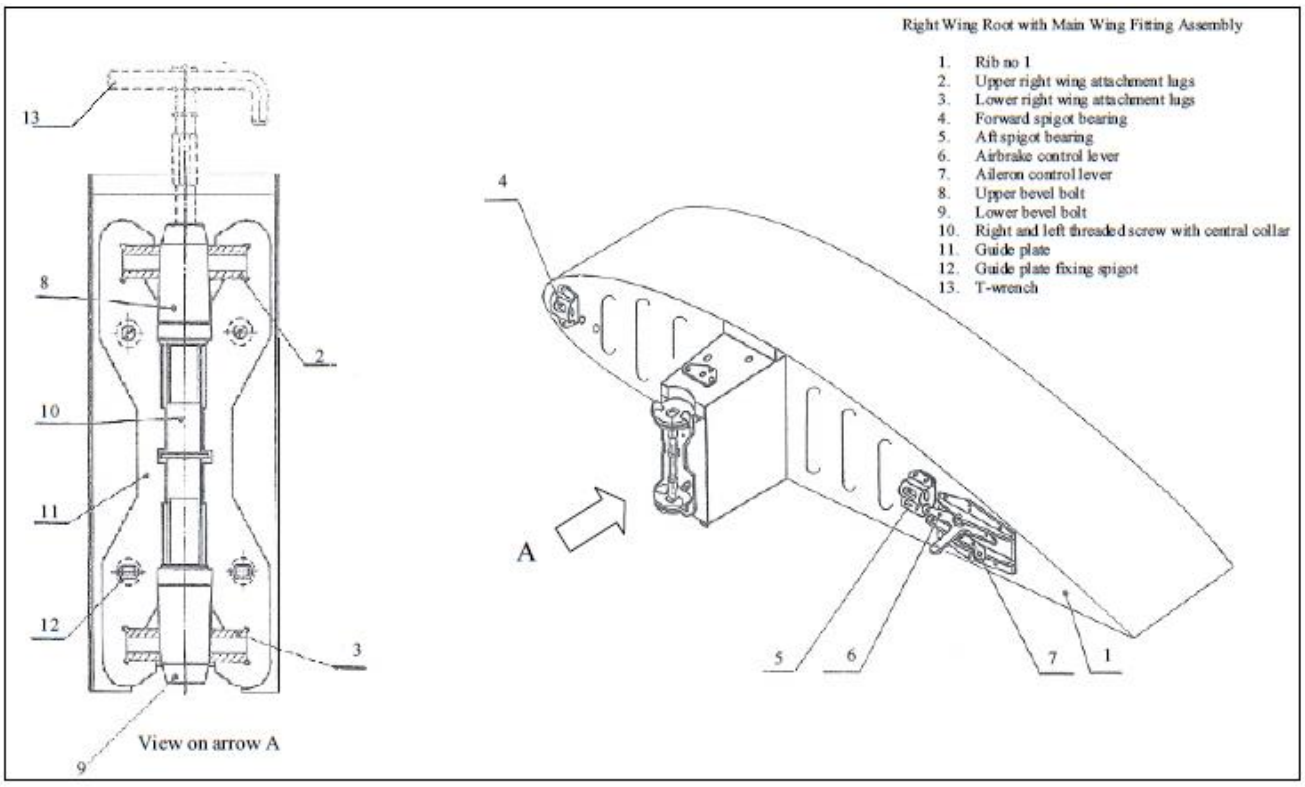
Example of an expanding main pin wing connection.

**Expanding Main Pins of Main Wing Connection**:
The wing rigging pins for most gliders are smooth cylinders, but those for e.g. the Foka, Cobra, Bocian, Jaskółka, Schempp-Hirth SHK and Austria, consist of expanding pins/cones, which must be fitted exactly in accordance with the instructions of the flight manual. If the pin/cone is not correctly located, the wings can fold up and detach from the fuselage. Unless inspection holes have been cut for the purpose, it can be very difficult in some gliders to see whether the fitting has been assembled correctly.

*Note: In case of sailplanes with expanding main pin wing connections, practice rigging should be carried out under the supervision of someone who is familiar with the sailplane type.*
